**GEO-SITE ASSESSMENT REPORT
PITSTONE SPORTS PAVILION
MARSWORTH ROAD, PITSTONE
BUCKINGHAMSHIRE
LU7 9AP**

DATE OF ISSUE: DECEMBER 2019

WDE Consulting Limited (WDE) was appointed by Pitstone Parish Council (the Client) to conduct a Geo-Site Assessment Report at Pitstone Sports Pavilion (Figure 1) to determine the ground conditions prior to the proposed extension to the existing pavilion building.

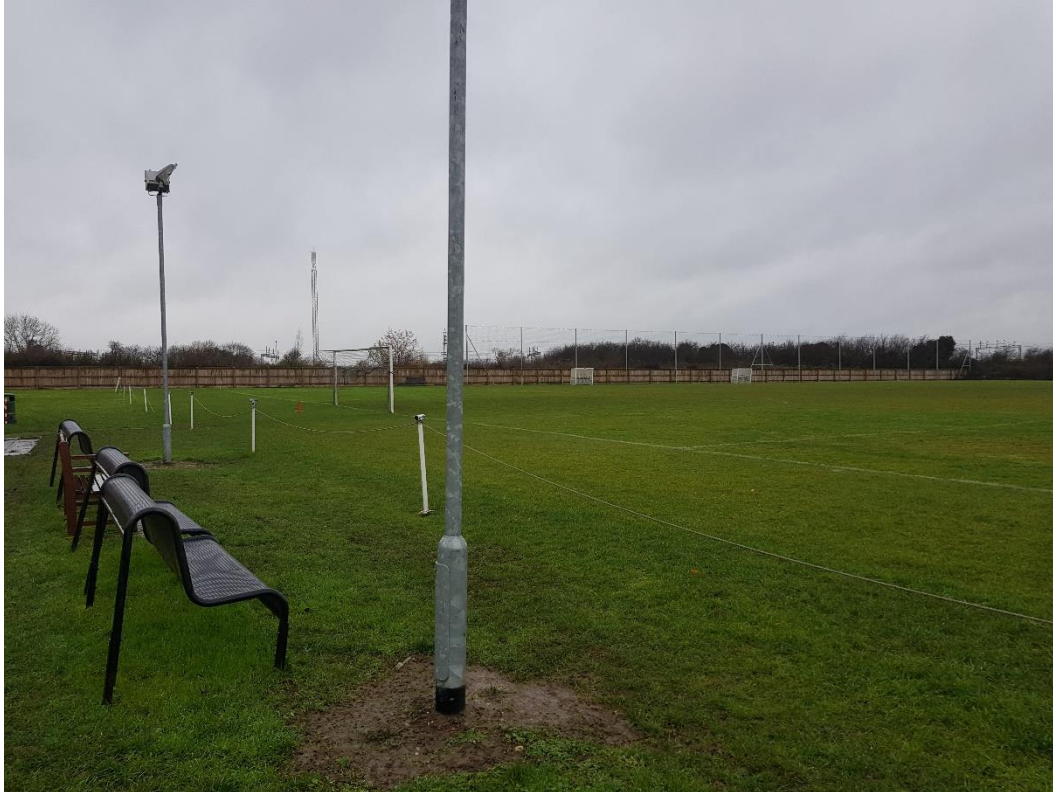
Photo 1: Football pitches

The entire site is 2.15ha are roughly square in shape with dimensions of ~140m east to west and ~130m north to south. Access to the site is via Marsworth Road on the southern boundary. The site comprises of 2no. football pitches, a sports pavilion and associated car park (Photos 1 and 2).

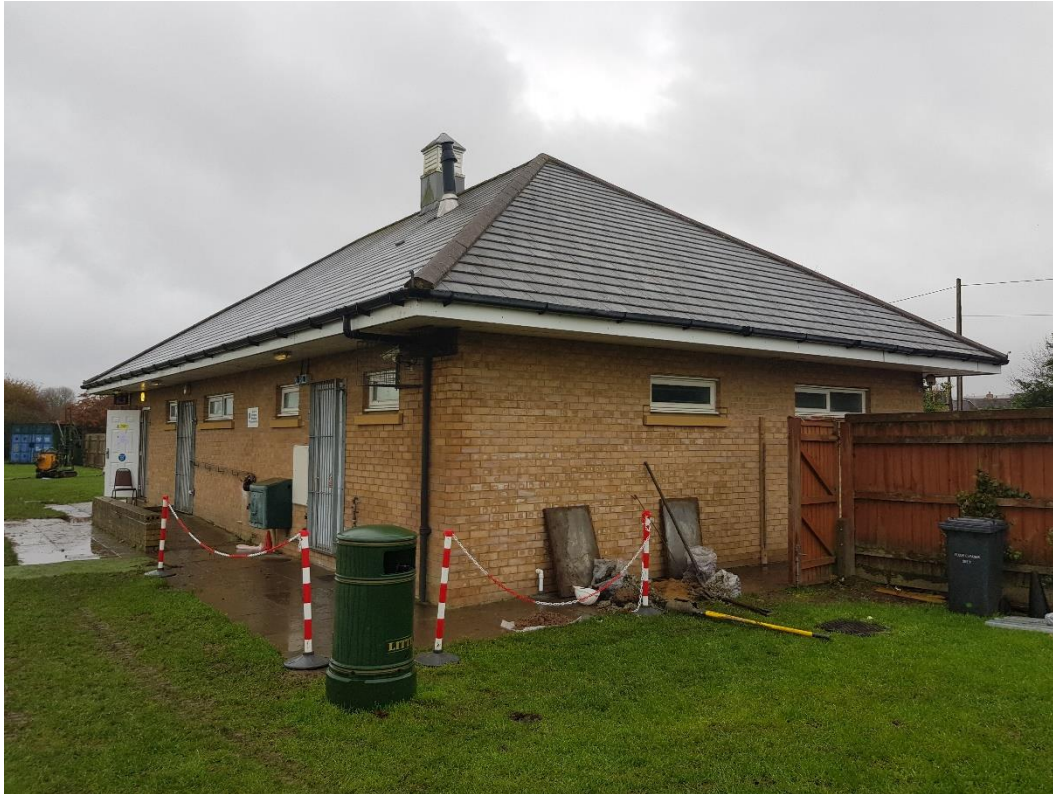
Photo 3: Existing Pavilion/ Changing Room block onsite

The football pitches cover the majority of the site with the pavilion and car park located on the southern boundary. The existing pavilion building consists of changing room, toilet and kitchen facilities for users of the pitches (Photo 3).

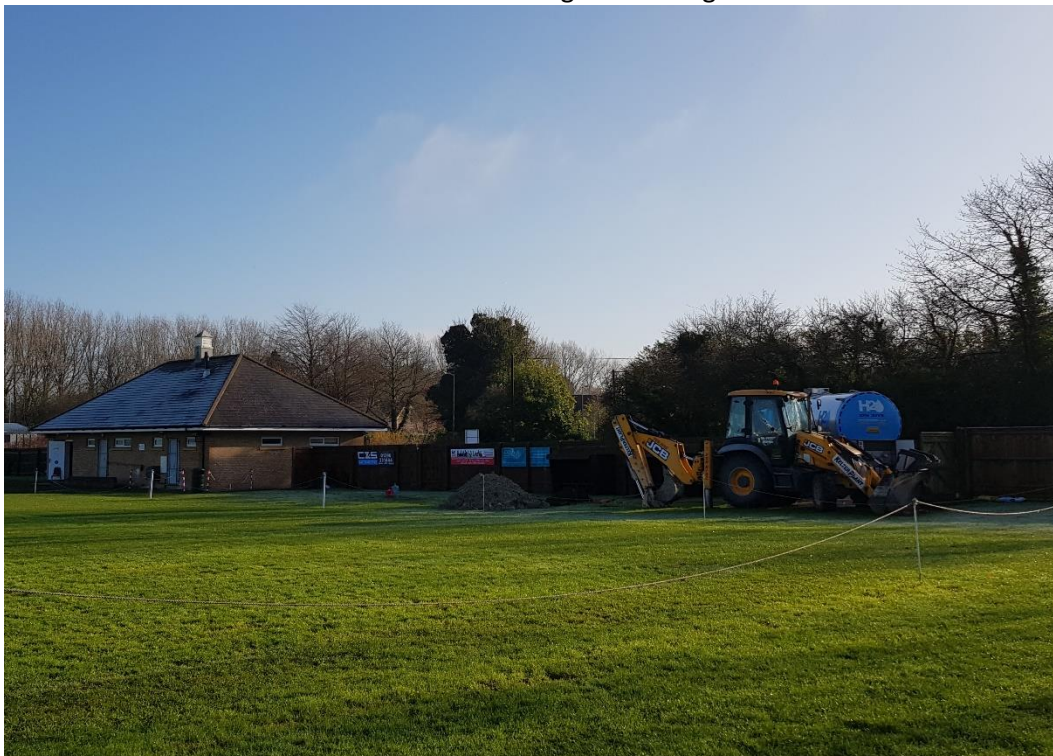
Photo 5: Foundation exposure pit (FDP1)

Location	Depth to top of footing (m bgl)	Depth to base of footing (m bgl)	Footing Materials	Founding Material	Comments
FDP1	0.68	1.56	Concrete	Silty Gravelly Chalky Clay	Photos 5&6

Traditional shallow strip foundations are therefore likely to be appropriate for consideration for the single storey building and will need to extend through the upper gravelly clay materials proving a minimum of 300mm of the natural chalk materials. It is recommended that the foundations are extended into the firm chalk materials (1.50m bgl) which would provide a bearing capacity of 125kN/m². Consideration should be given to extending the foundations around BH2 where firmer materials were encountered from 2.00m bgl.

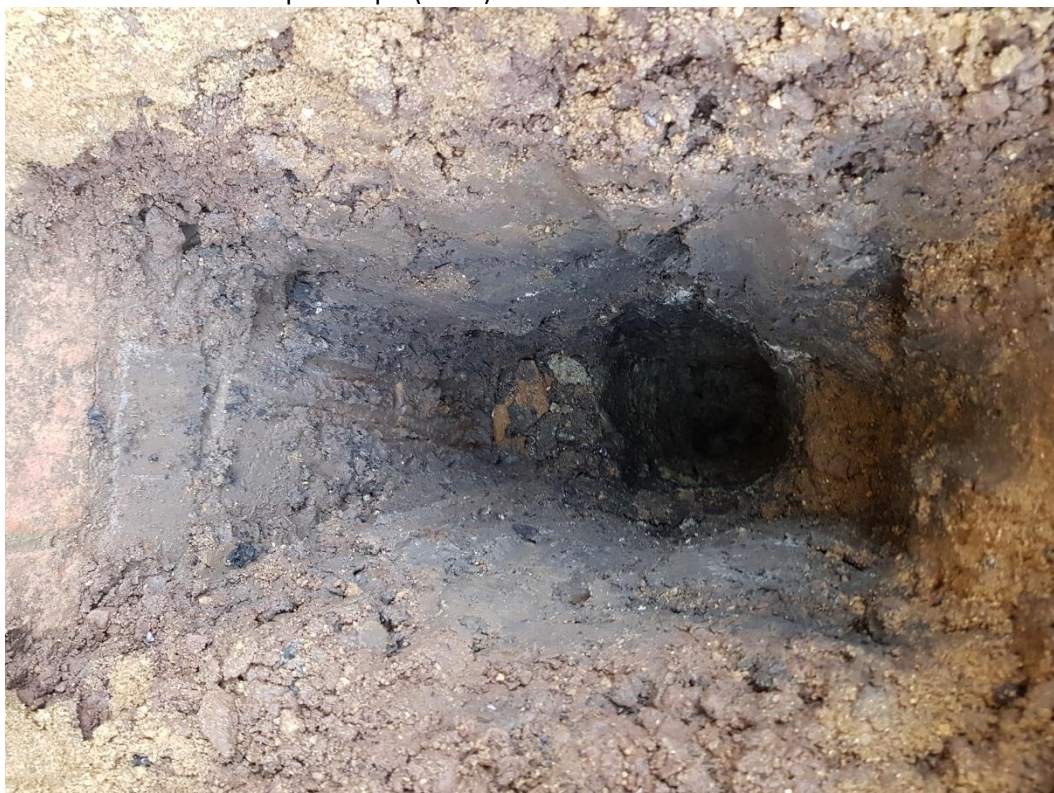
Photo 6: Foundation exposure pit (FDP1)

- 3no. boreholes (BH1 to BH3) were drilled to a maximum depth of 5.00m bgl with 1no. monitoring well installations (BH3).
- 5no. Dynamic Probes (DP1 to DP5) were drilled to a maximum depth of 5.00m bgl.
- 1no. trial pit (SA1) was excavated using a JCB 3CX to a depth of 3.00m bgl for BRE soakage testing (Photo 4)
- 1no. foundation pit (FDP1) was hand dug to prove the depths of the existing foundations (Photo 5 & 6).

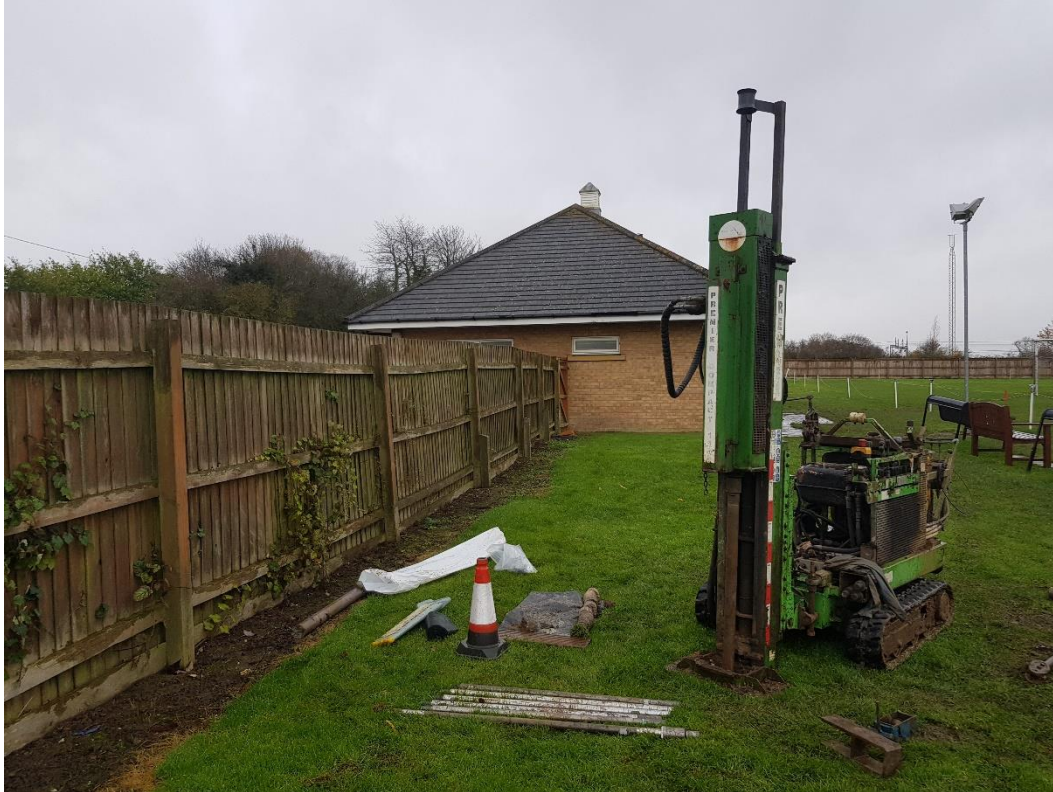
Photo 7: Window sampling rig drilling in BH2

Boreholes and dynamic probes were drilled using a mechanical window sampling rig (Photo 7) to investigate the ground conditions. All of the fieldwork was completed under the supervision of a WDE site engineer. Logs for each of the intrusive locations are presented in Appendix E. Organic Vapour Concentrations (OVCs) were measured during the fieldwork on recovered soil samples using a Photo-ionisation Detector (PID). Soil samples were transported within a cooler box to a UKAS accredited laboratory under chain of custody conditions.

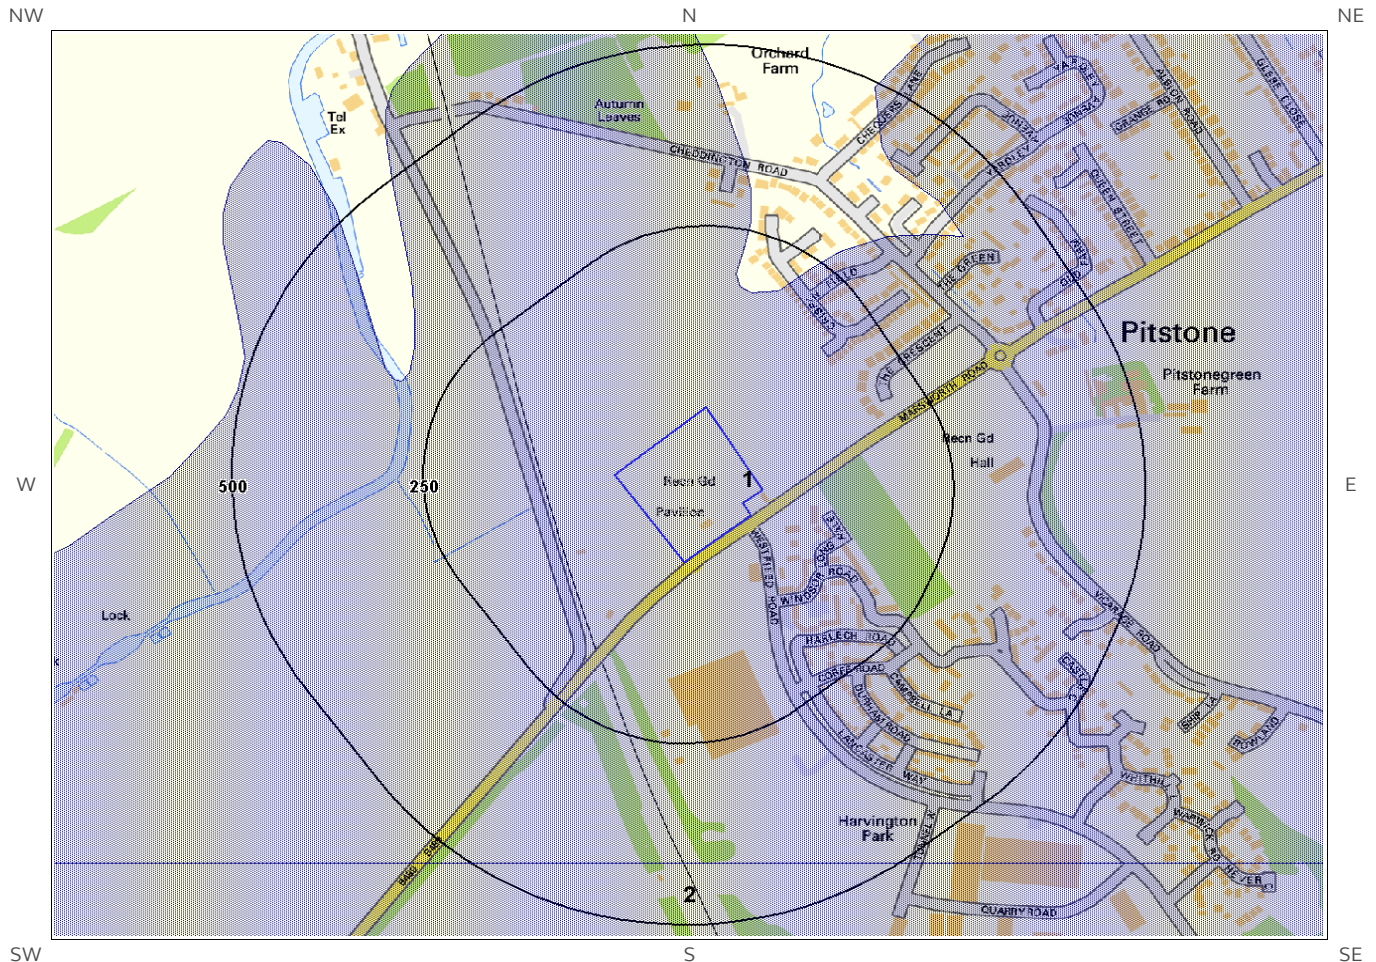
5 Mining, Extraction & Natural Cavities map

ID	Distance (m)	Direction	Name	Commodity	Assessment of likelihood
1	0.0	On Site	Not available	Chalk	Sporadic underground mining of restricted extent may have occurred. Potential for difficult ground conditions are unlikely and localised and are at a level where they need not be considered

ID	Distance (m)	Direction	Name	Commodity	Assessment of likelihood
2	414.0	S	Not available	Chalk	Sporadic underground mining of restricted extent may have occurred. Potential for difficult ground conditions are unlikely and localised and are at a level where they need not be considered

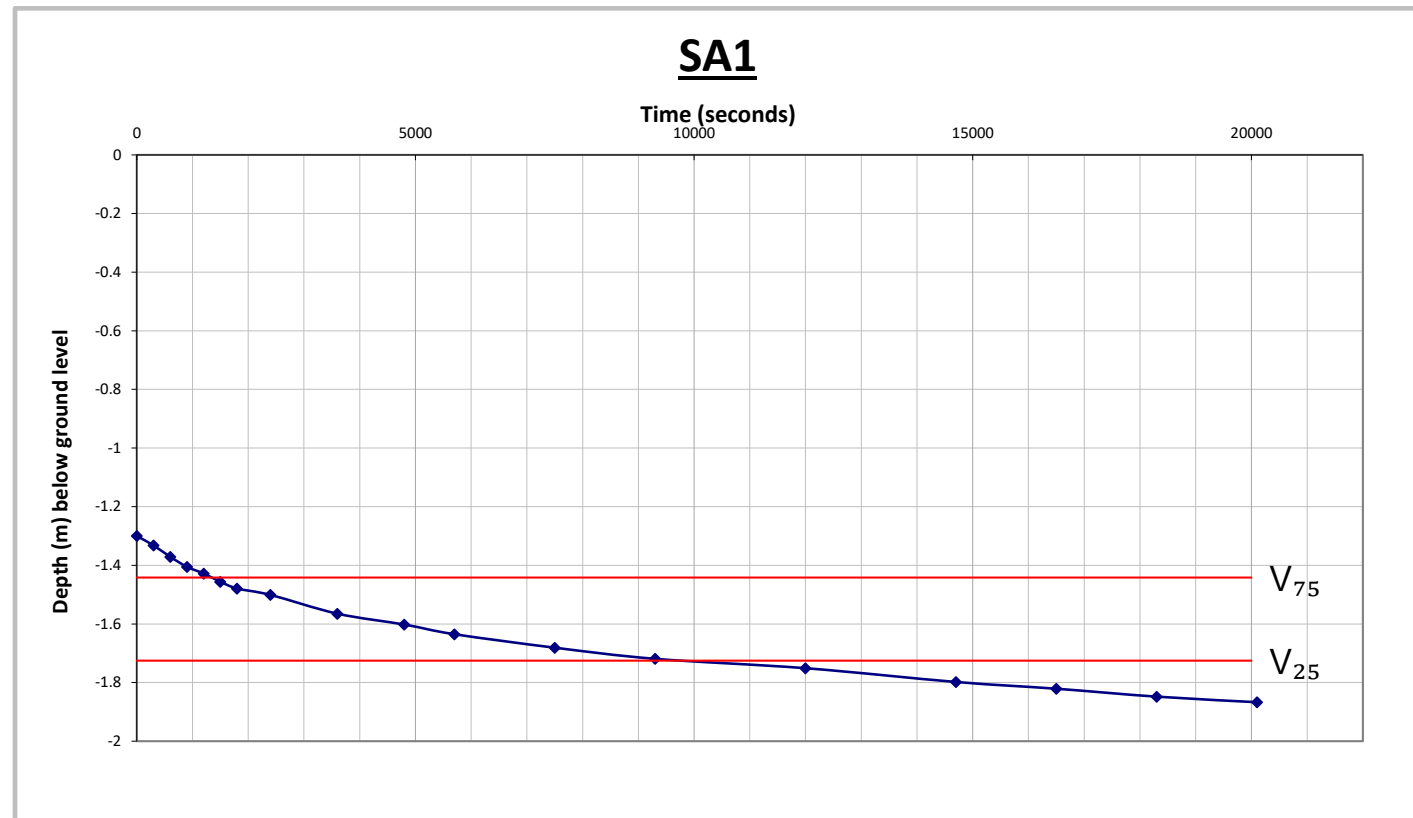
Although the borehole falling head test indicates poor permeability the BRE soakage test indicates moderate permeability onsite. Therefore discharge to ground is likely to be possible onsite; however it is recommended a drainage engineer is consulted to formulate the drainage design.

Pit failed to drain completely, calculation therefore based on water lost (in line with BRE guidance). However no refills could be conducted due to slow drainage.

Due to the encountered low density chalk it is recommended that soakaways are located a minimum of 10m from the pavilion footprint, in line with CIRIA guidance⁶.

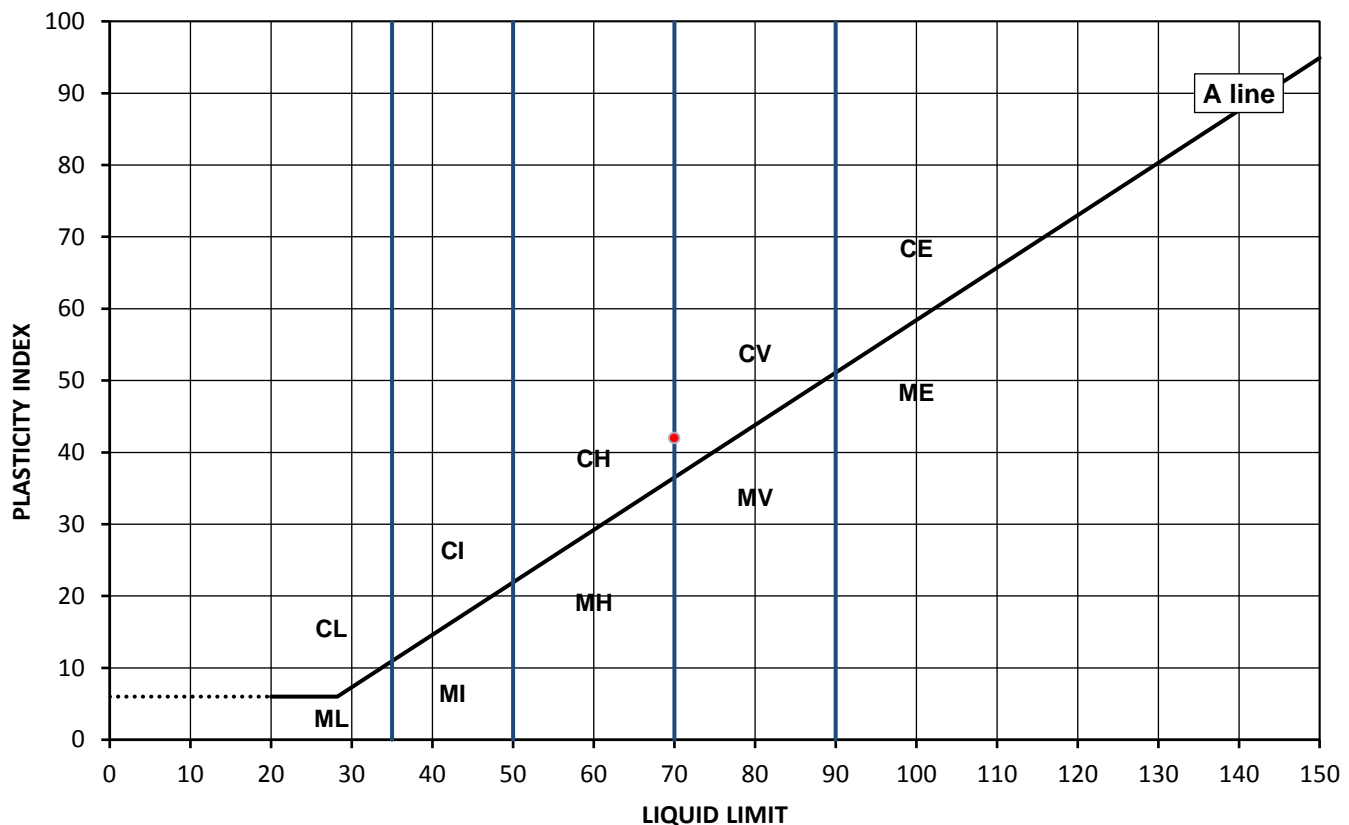
Testing of the underlying structureless chalk has returned a high plasticity value and the plasticity index (42%) indicates that there is a high-volume change potential of the chalk. The dry density and saturation moisture content results indicate that the chalk is Low density. Shear strength results indicate that the chalk is firm between 1.00-2.00m bgl in BH1 and BH3 whilst a soft result was returned between 2.00 and 3.00m bgl in BH2.

As Received Moisture Content [%]	Liquid Limit [%]	Plastic Limit [%]	Plasticity Index [%]	% Passing 425µm BS Test Sieve
27	70	28	42	100

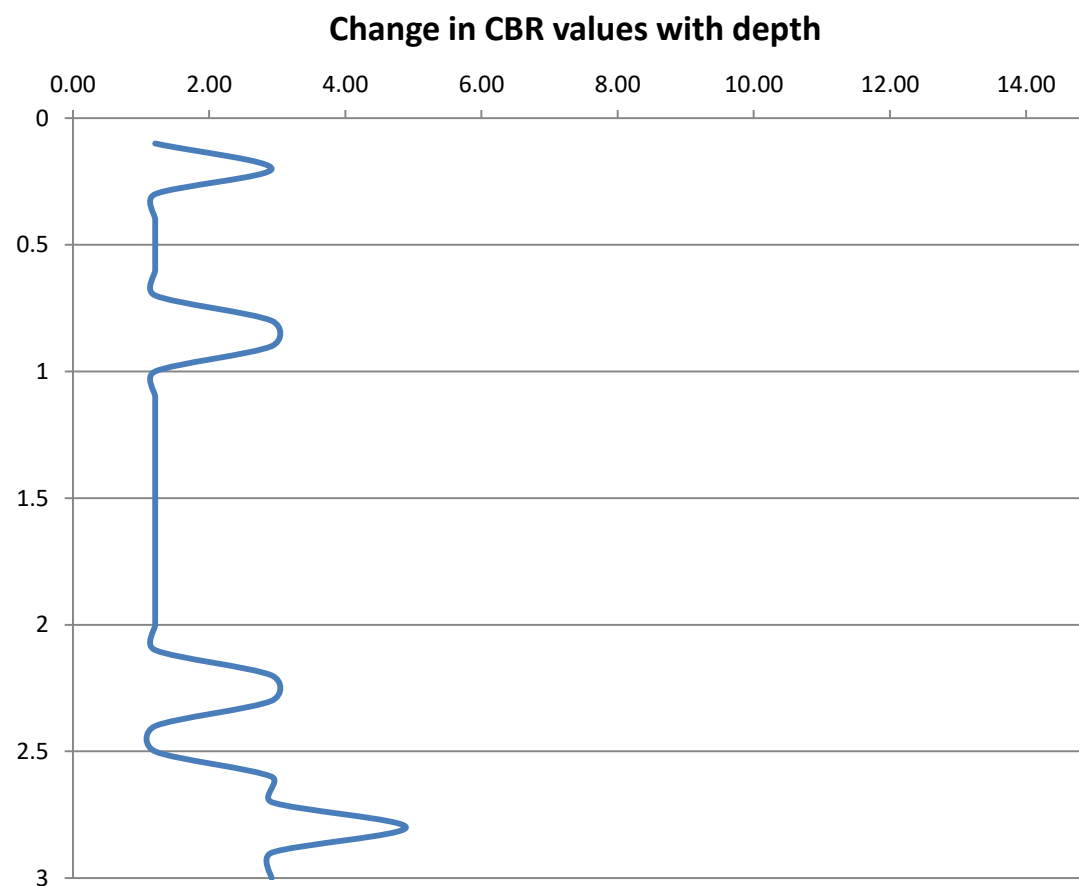
Date of Test	26/11/2019
Completed by	TC
Site Name	Pitstone Sports Pavilion
Hole number	DP3

Depth (m)	CBR (%)
0.1	1.21
0.2	2.92
0.3	1.21
0.4	1.21
0.5	1.21
0.6	1.21
0.7	1.21
0.8	2.92
0.9	2.92
1.0	1.21
1.1	1.21
1.2	1.21
1.3	1.21
1.4	1.21
1.5	1.21
1.6	1.21
1.7	1.21
1.8	1.21
1.9	1.21
2.0	1.21
2.1	1.21
2.2	2.92
2.3	2.92
2.4	1.21
2.5	1.21
2.6	2.92
2.7	2.92
2.8	4.89
2.9	2.92
3.0	2.92

Values calculated using Kleyn & Van Harden (1983) conversion.

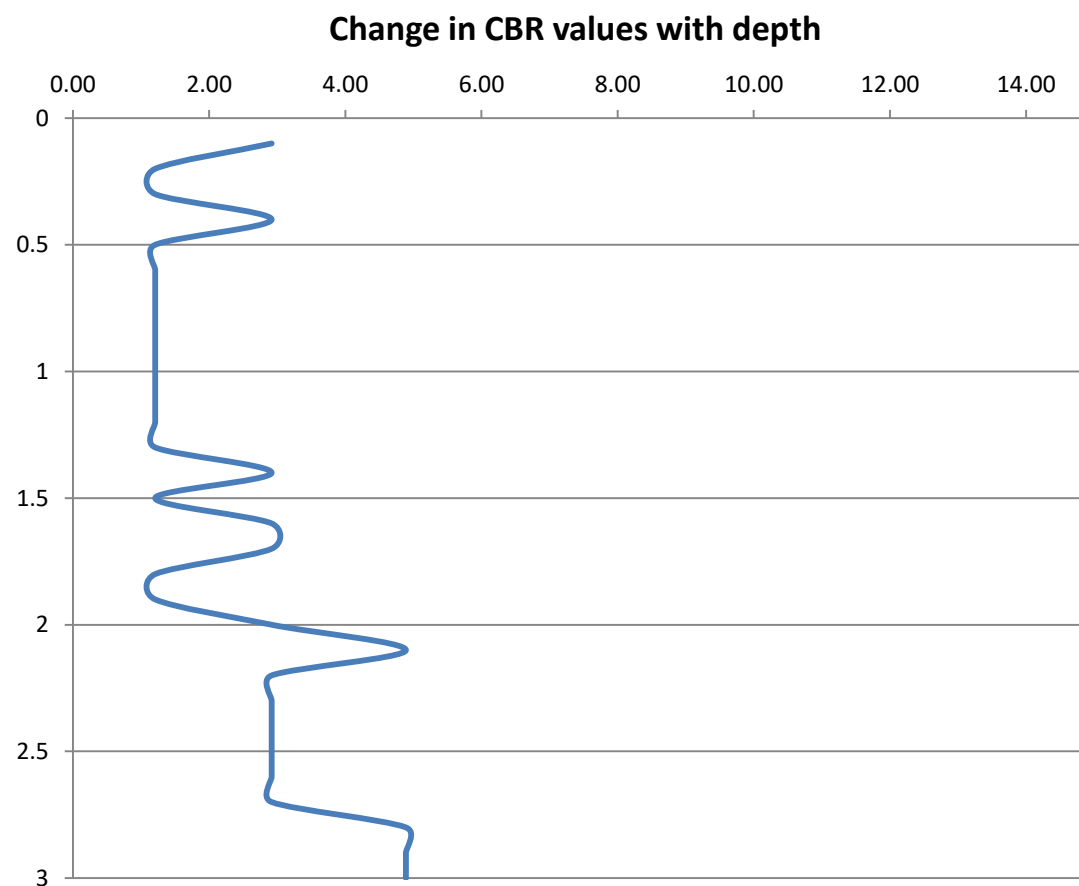
Date of Test	26/11/2019
Completed by	TC
Site Name	Pitstone Sports Pavilion
Hole number	DP5

Depth (m)	CBR (%)
0.1	2.92
0.2	1.21
0.3	1.21
0.4	2.92
0.5	1.21
0.6	1.21
0.7	1.21
0.8	1.21
0.9	1.21
1.0	1.21
1.1	1.21
1.2	1.21
1.3	1.21
1.4	2.92
1.5	1.21
1.6	2.92
1.7	2.92
1.8	1.21
1.9	1.21
2.0	2.92
2.1	4.89
2.2	2.92
2.3	2.92
2.4	2.92
2.5	2.92
2.6	2.92
2.7	2.92
2.8	4.89
2.9	4.89
3.0	4.89

Values calculated using Kleyn & Van Harden (1983) conversion.

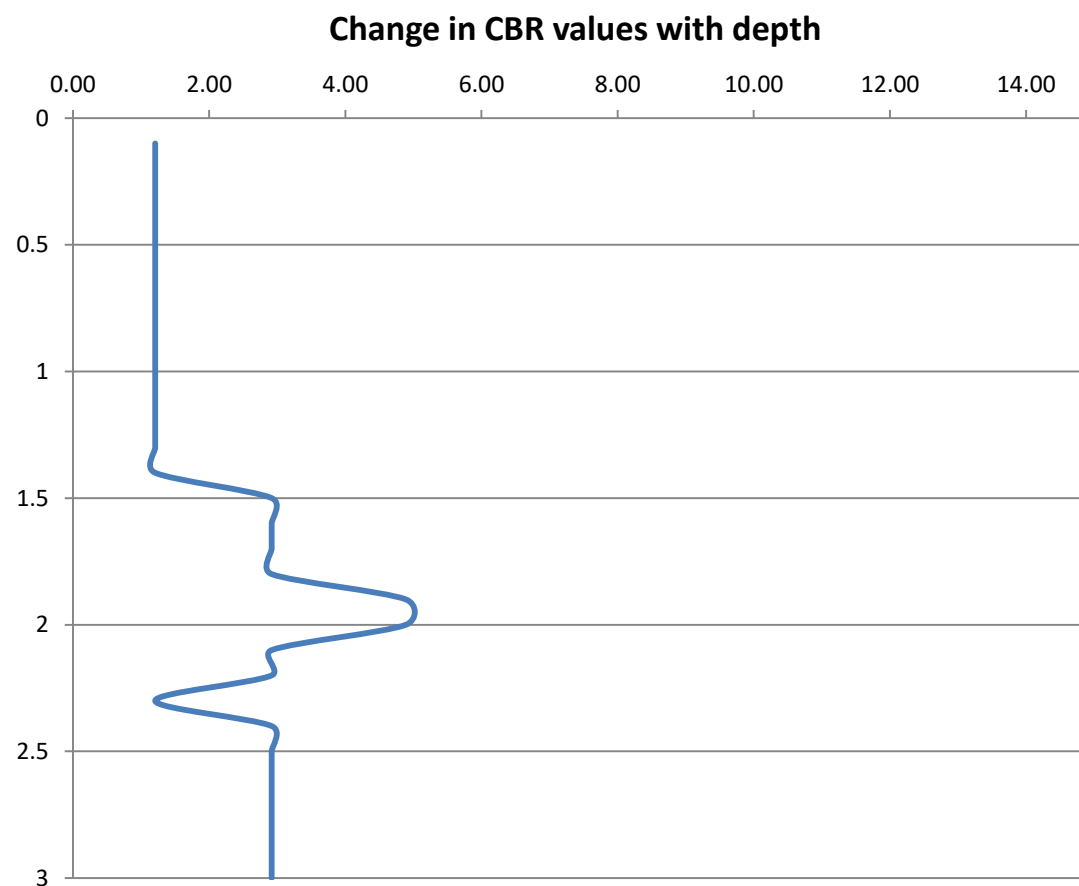
CBR Conversion calculation $\log CBR = 2.628 - 1.273 \log(DCP)$

Depth (m)	CBR (%)
0.1	1.21
0.2	1.21
0.3	1.21
0.4	1.21
0.5	1.21
0.6	1.21
0.7	1.21
0.8	1.21
0.9	1.21
1.0	1.21
1.1	1.21
1.2	1.21
1.3	1.21
1.4	1.21
1.5	2.92
1.6	2.92
1.7	2.92
1.8	2.92
1.9	4.89
2.0	4.89
2.1	2.92
2.2	2.92
2.3	1.21
2.4	2.92
2.5	2.92
2.6	2.92
2.7	2.92
2.8	2.92
2.9	2.92
3.0	2.92
